Upgrading the 1971 Side Stand Lug

This article covers the procedure of replacing the existing side stand lug on the 1971 Commando with the later version bracket.

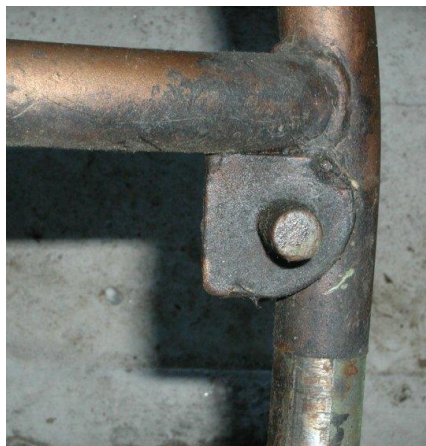
Photo 1: The stock side stand lug on a 1971 frame, looking at the bottom of the bracket.

There are two reasons to upgrade the '71 side stand lug. 1) The pin on the 1971 machine holding the side stand would break off and 2) the side stand is no longer available.

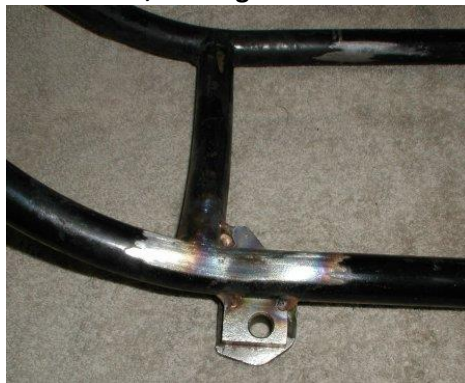
Photo 2: Frame with the new bracket installed.

Please Note: Do not weld the top part of the bracket to the frame in the centre. Allow room for the nut and washer holding the side stand to fit flush against the top of the bracket. The second picture in this article shows the welds just on the end of the top.

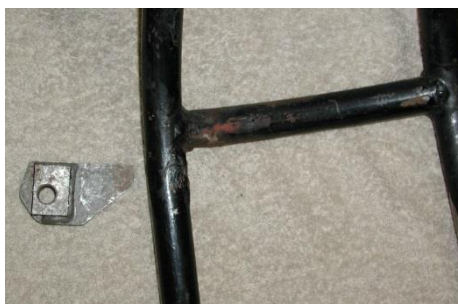
Photo 3: The frame with the old bracket removed and the new bracket to be installed.

Remove the old bracket by cutting and grinding off the old bracket, trying not to damage the frame tubes.

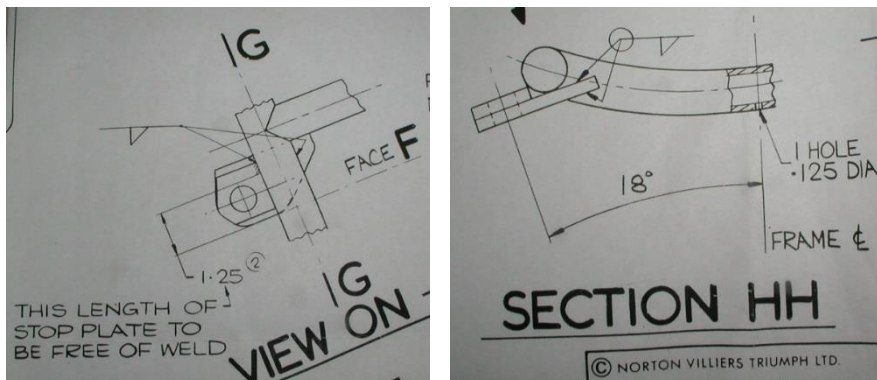
This is how the new bracket is to be positioned and welded to the frame.

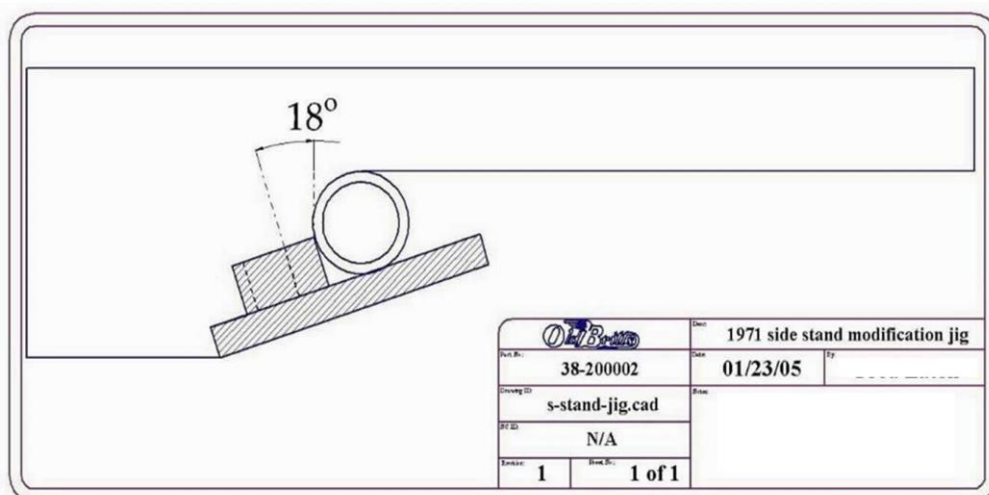
This is a pattern to set the new bracket at the correct angle.

Photo 4: A picture of the pattern drawing.

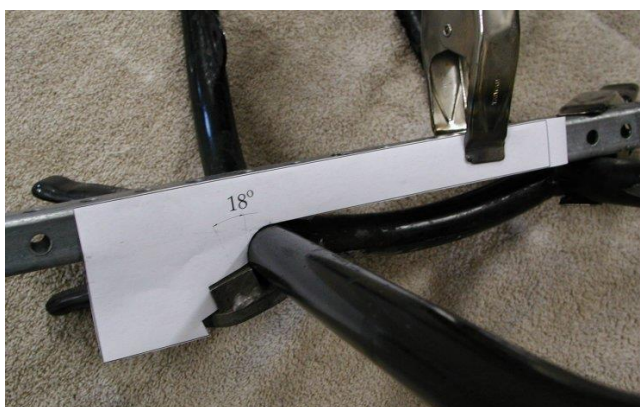
A picture of the new bracket held to the frame with spring clamps and using our pattern to get the correct placement. A square tube is positioned across both lower frame tubes just above where the new bracket is to be welded.
