## Upgrading the 1971 Side Stand Lug

### Summary:

This article covers the procedure of replacing the existing side stand lug on the 1971 Commando with the later version bracket. There are two reasons to upgrade the '71 side stand lug -- the pin on the '71 holding the side stand would break off and the '71 version of the side stand is no longer available. There are bolt-on side stands available that bolt around the frame tube, but these bolt-on stands tend to crimp the frame tube if used improperly. This procedure is normally done when a complete frame up restoration is being performed.

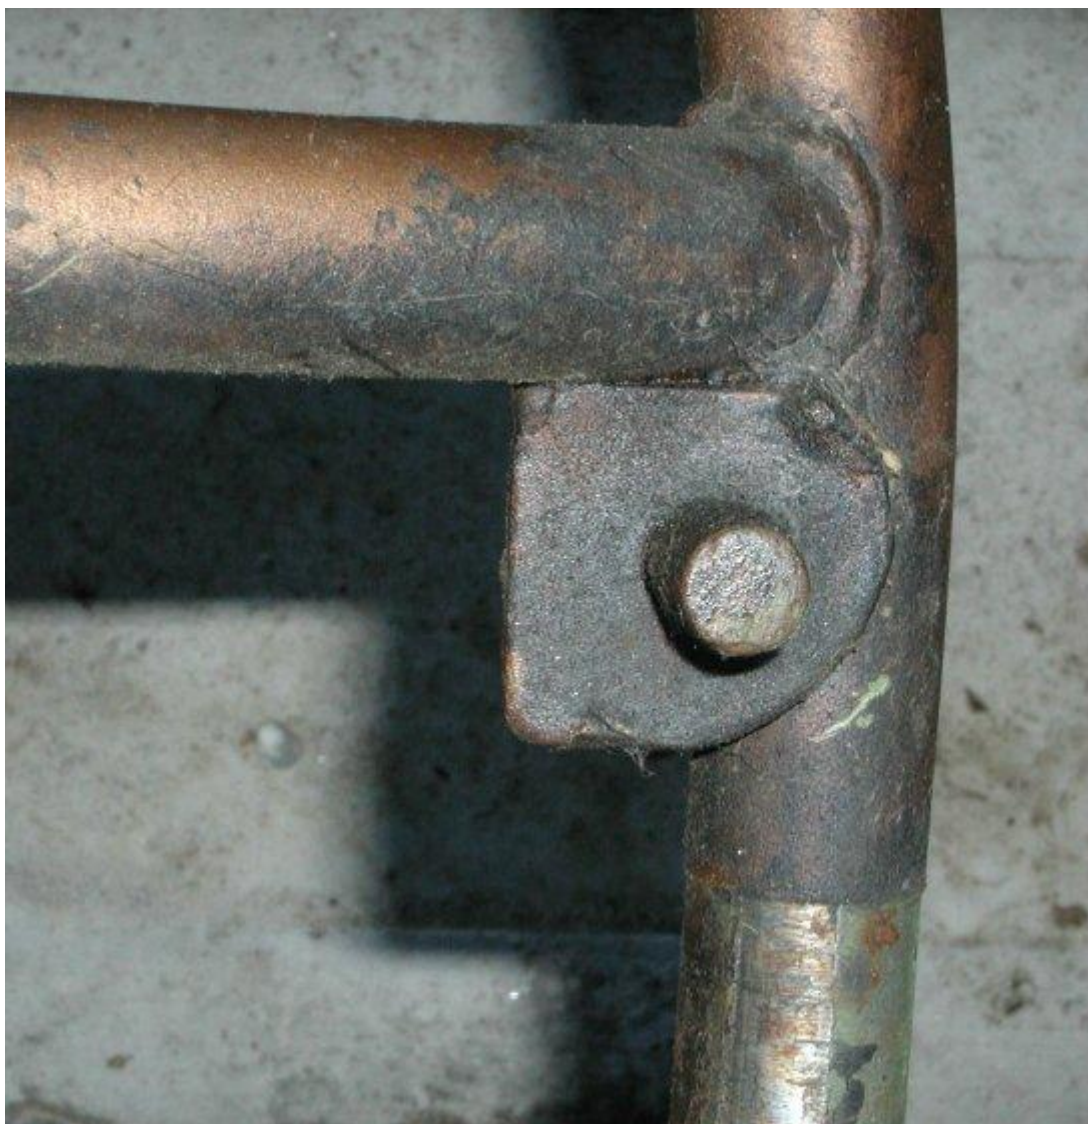
**A picture of the stock side stand lug on a 1971 frame, looking at the bottom of the bracket.**

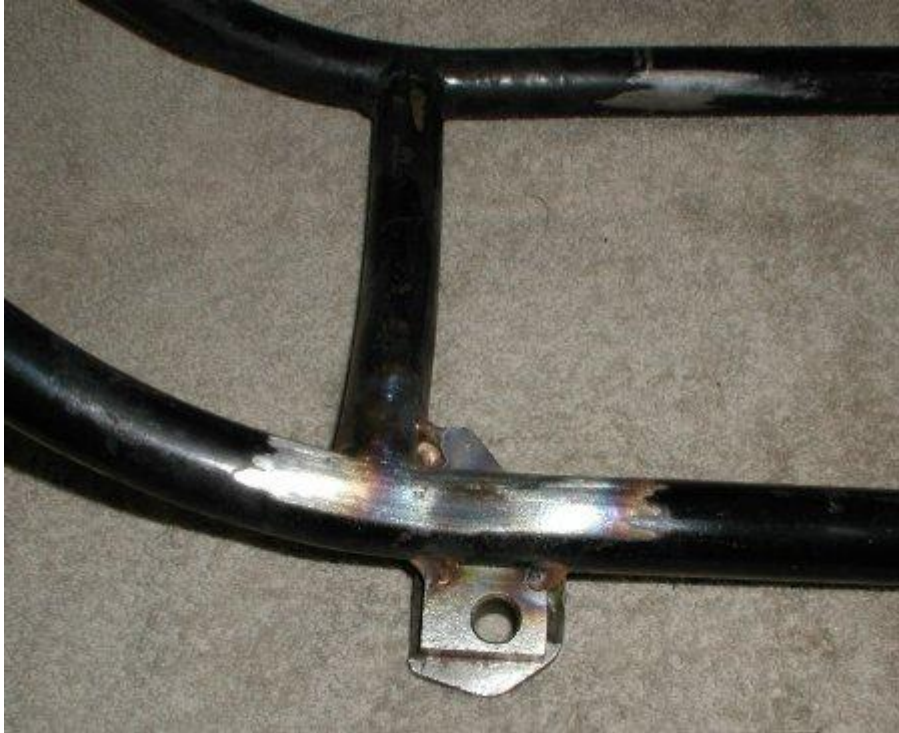
**A picture of a frame with the new bracket installed.**

Please Note: Do not weld the top part of the bracket to the frame in the center. You need to allow room for the nut and washer holding the side stand to fit flush against the top of the bracket. The second picture in this article shows the welds just on the end of the top.

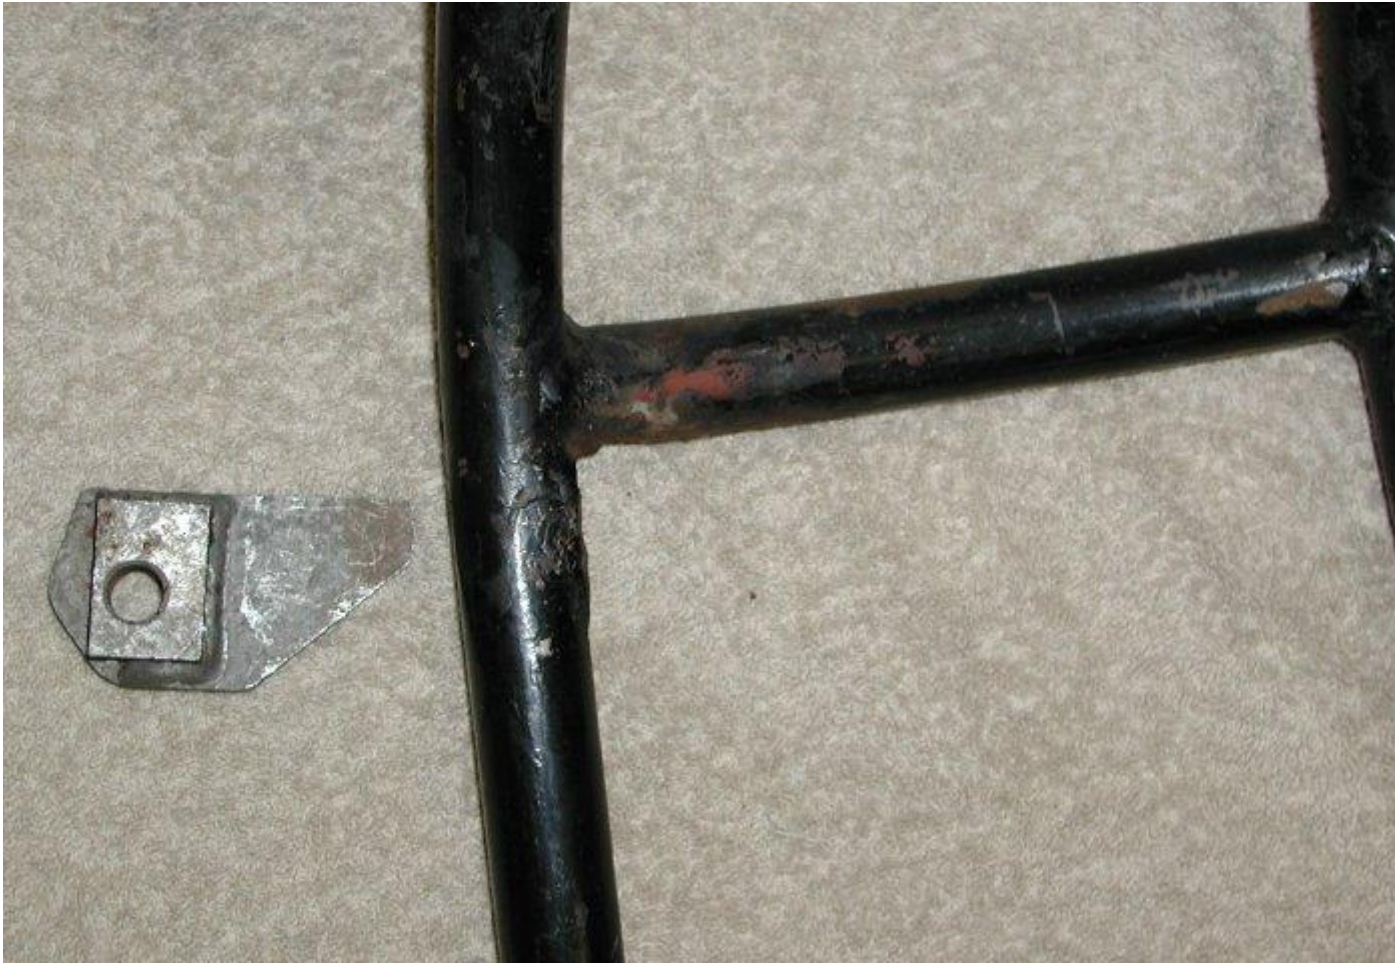
**A picture of the frame with the old bracket removed and the a new bracket to be installed.**

The first step is to remove the old bracket by cutting and grinding off the old bracket, trying not to damage the frame tubes.

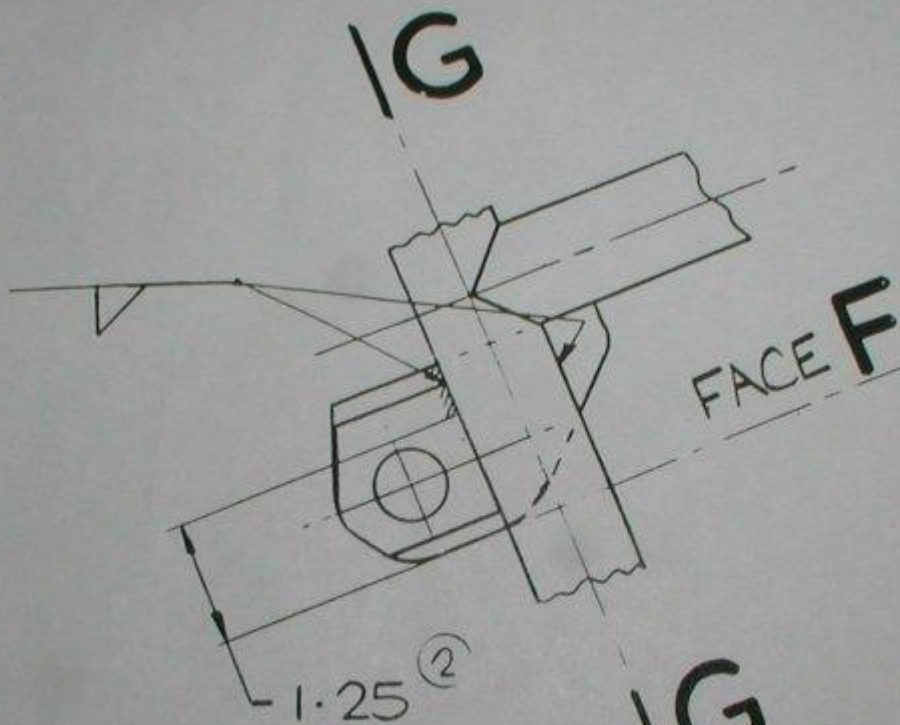
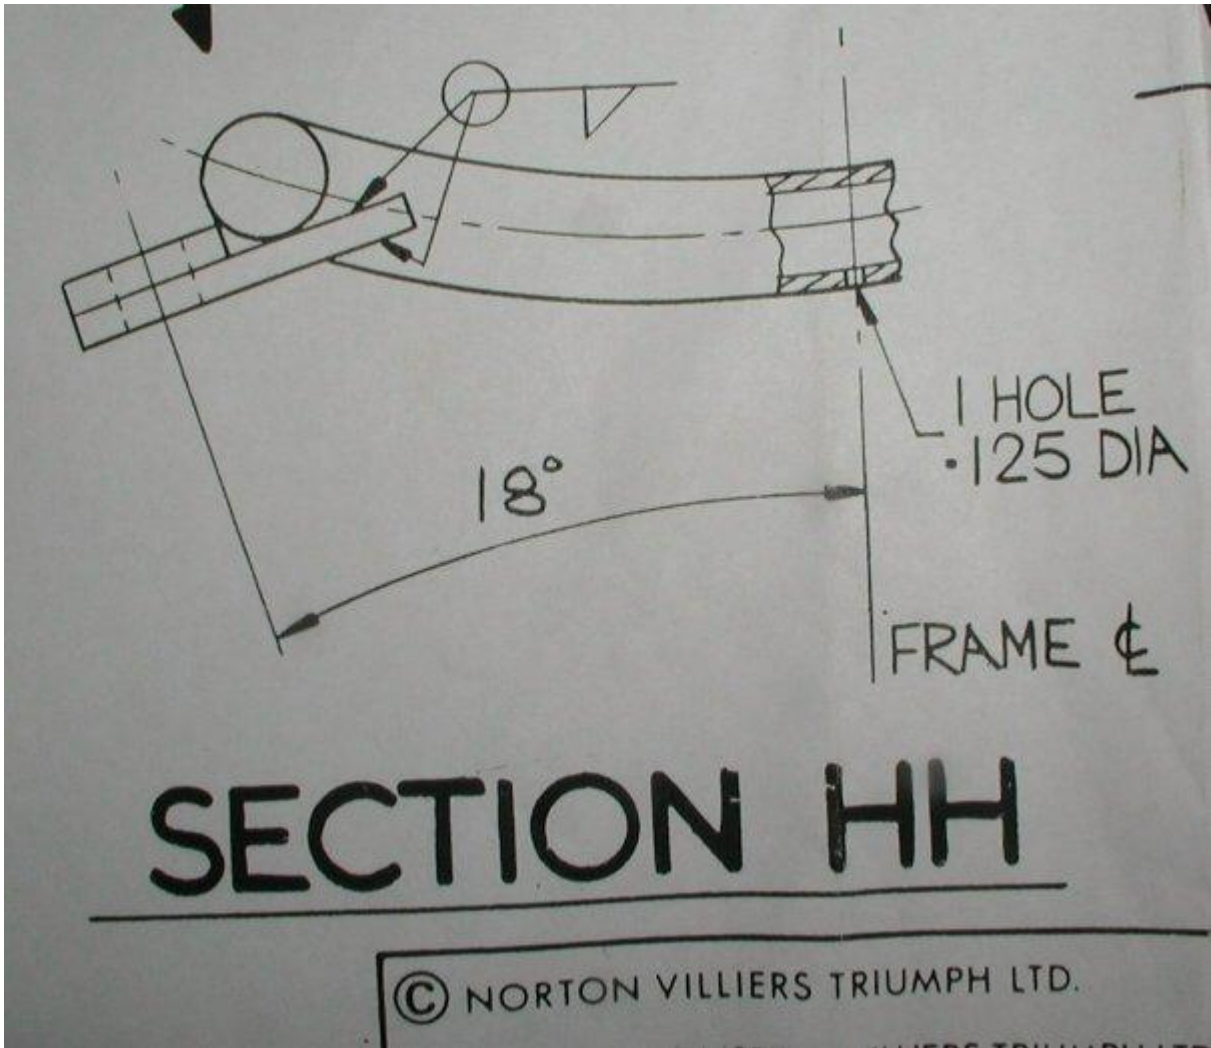
THIS LENGTH OF  
STOP PLATE TO  
BE FREE OF WELD

VIEW ON

I drew up a pattern to make setting the new bracket at the correct angle. This drawing is printed actual size so you can cut out the pattern, tape it to a piece of cardboard or something straight and position the bracket for welding.

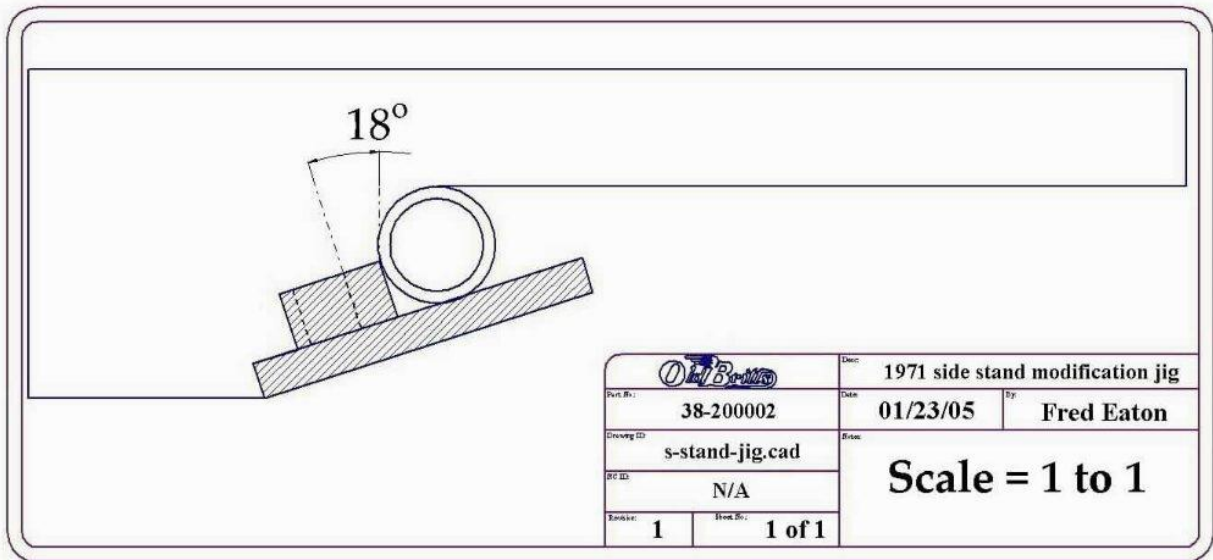
**A picture of our pattern drawing that we make available and include with the side stand bracket.**

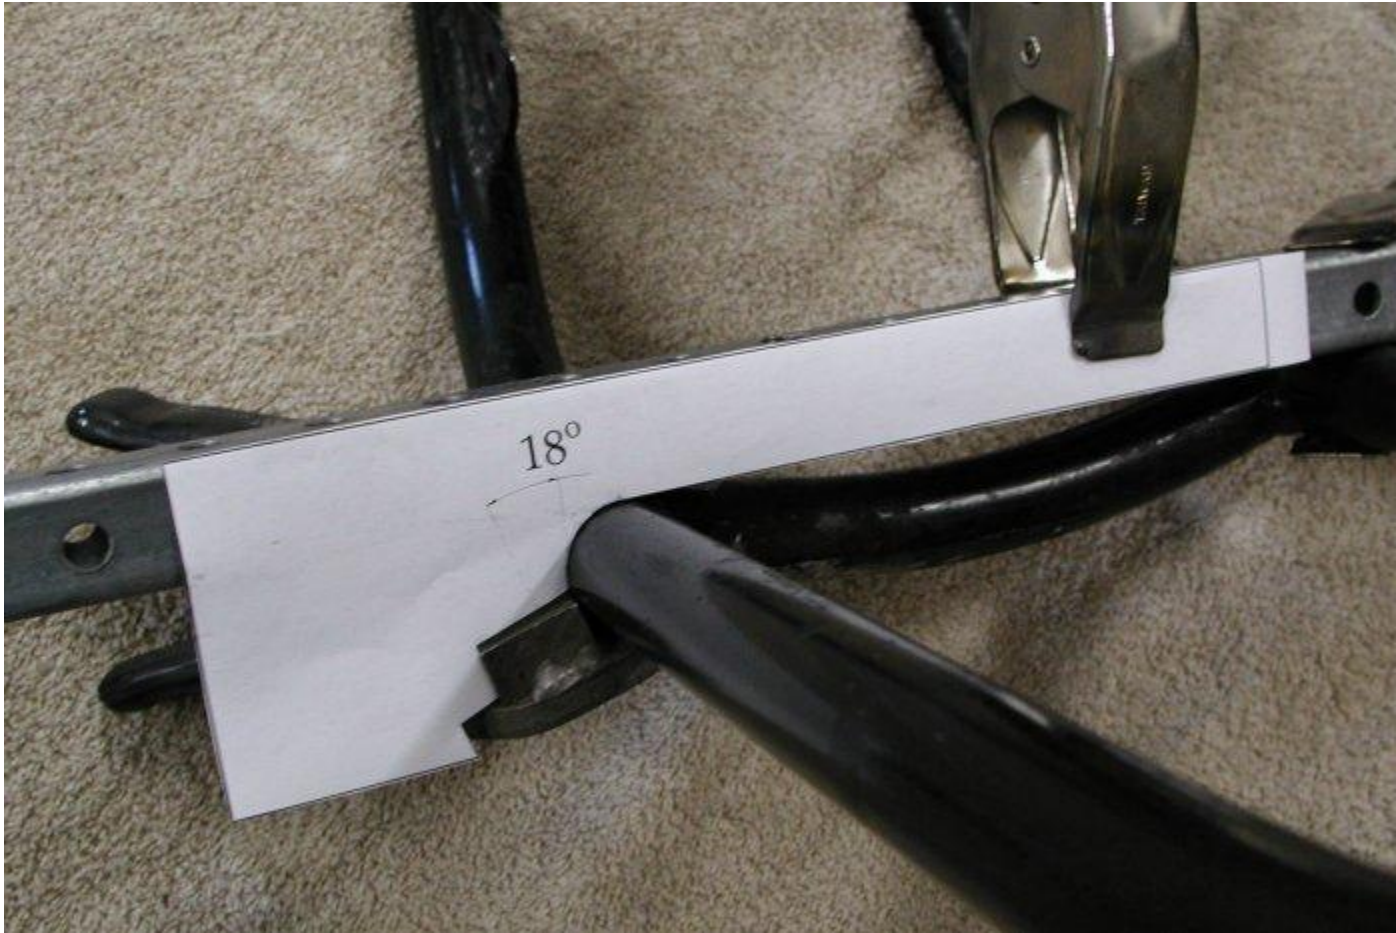
A picture of the new bracket held to the frame with spring clamps and using our pattern to get the correct placement. A square tube is layed accross both lower frame tubes just above where the new bracket is to be welded.
